## Summary

Property address: **Fairfield OH 45014**

Inspection date: **Wednesday, January 21, 2015**

## Residential Property Inspection Report

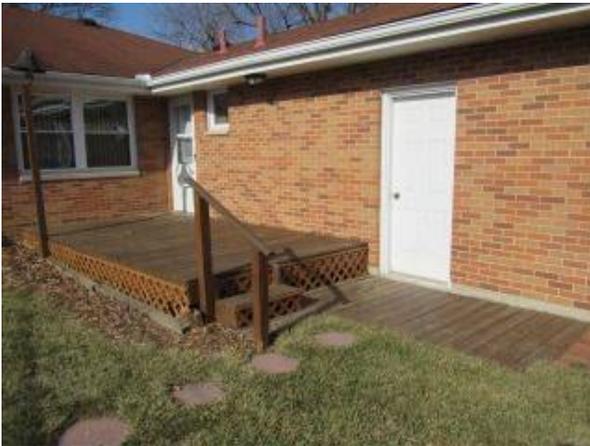
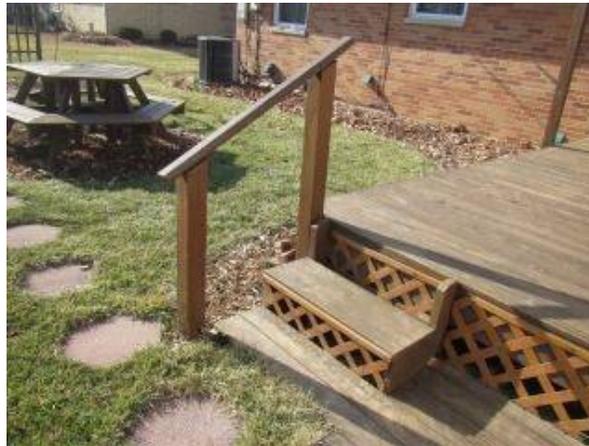
- Wooden deck or porch surfaces were overdue for normal maintenance. Recommend that a qualified person clean and preserve as necessary. Where decks have been coated with a finish such as opaque stains or paint, it may be too difficult to strip the finish and apply anything but paint or opaque stain. Where transparent stain or penetrating oil has been applied in the past, recommend that a penetrating oil be used. For more information, visit:

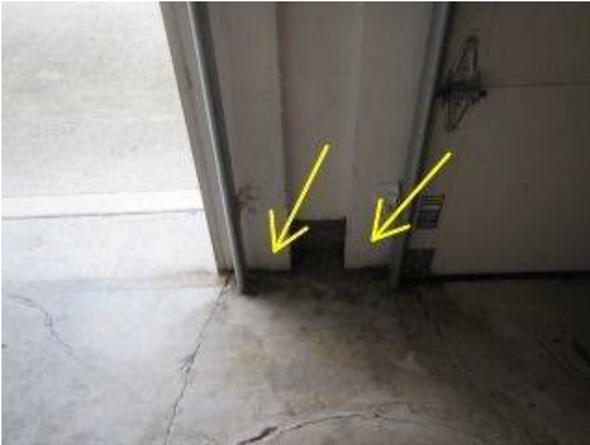
Photo 4-1

- No photoelectric sensors were installed for one or more garage vehicle doors' automatic opener. These have been required on

all automatic door openers since 1993 and improve safety by triggering the door's auto-reverse feature without need for the door to come in contact with the object, person or animal that is preventing the door from closing. Recommend that a qualified contractor install photoelectric sensors where missing for improved safety. For more information on garage door safety issues, visit: <http://www.reporthost.com/?GDPEs>

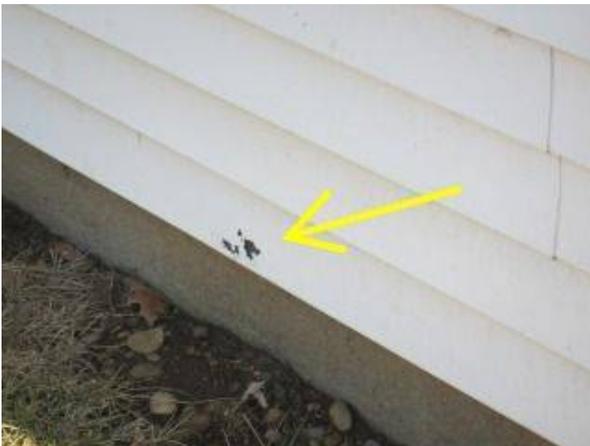
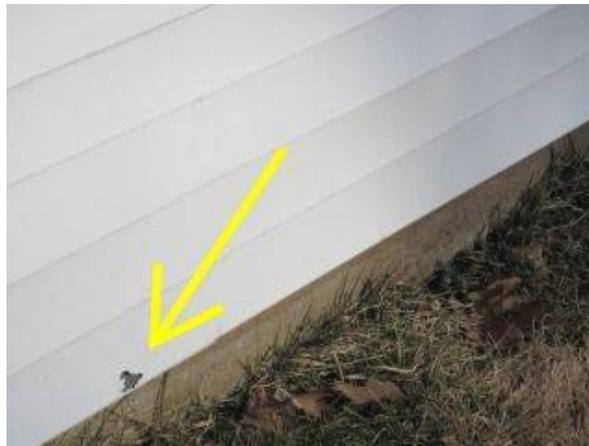
- Minor chipping of vinyl siding at ground level probably caused by a weed wacker. Recommend monitoring. Potential for moisture intrusion and wood destroying organisms.

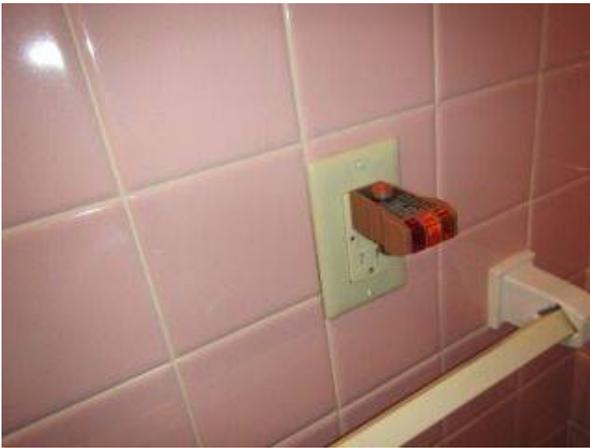
Photo 7-1

- One ground fault circuit interrupter (GFCI) receptacles (outlets) wouldn't trip with a test instrument at the bathroom off the 1st floor hall. This is a potential shock hazard. Recommend that a qualified electrician evaluate and repair as necessary.

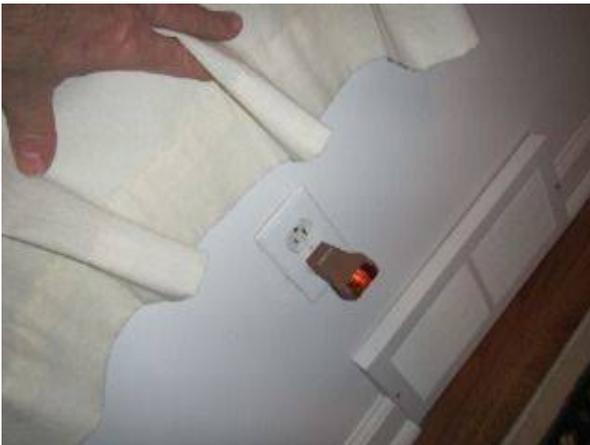
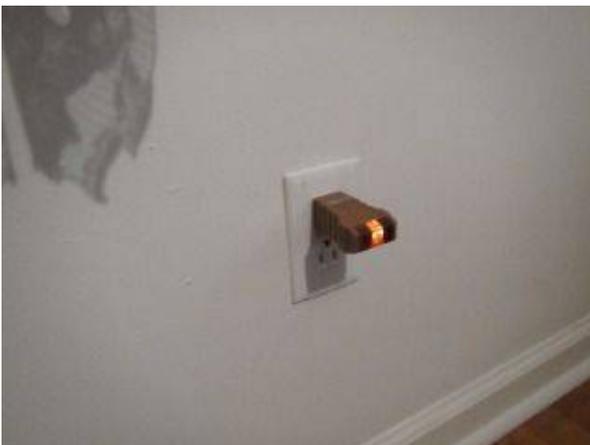
- One or more modern, 3-slot electric receptacles (outlets) were found with an open ground. Three-slot receptacles should have a hot, a neutral and a ground wire connected. Homeowners often install new 3-slot receptacles on older, 2-wire circuits that only have hot and neutral wires. This is a shock hazard when appliances that require a ground are used with these receptacles. Examples of such appliances include computers and related hardware, refrigerators, freezers, portable air conditioners, clothes washers, aquarium pumps, and electrically operated gardening tools. Where the electric system was installed prior to when grounded circuits were required (1960s), it is permissible to replace 3-slot receptacles with 2-slot receptacles to prevent appliances that require a ground from being plugged in to an ungrounded circuit. However, the client should be aware of this limitation when planning use for various rooms, such as an office. For newer electric systems, circuits should be repaired so grounded, 3-wire cables provide power to 3-slot receptacles. Recommend that a qualified electrician repair per standard building practices.

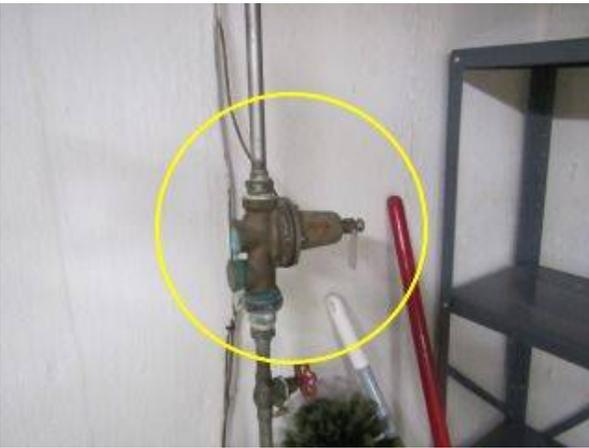
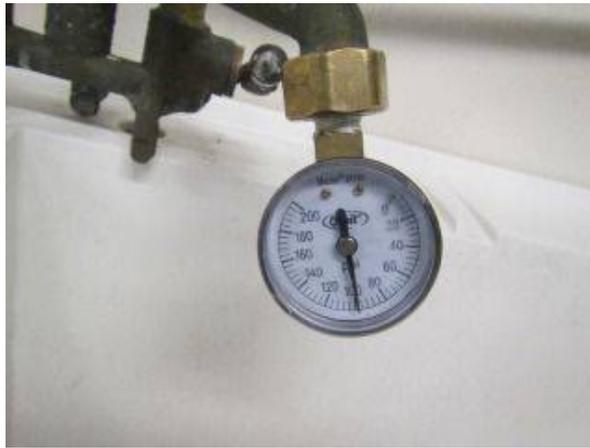
- The water supply pressure from the public supply was greater than 80 pounds per square inch (PSI). Pressures above 80 PSI may void warranties for some appliances such as water heaters or washing machines. Flexible supply lines to washing machines are likely to burst with higher pressures. 40-80 PSI is considered the normal range for water pressure in a home, and most plumbers recommend 50-60 PSI. Typically, the pressure cannot be regulated at the water meter. Recommend that a qualified plumber evaluate and make modifications to reduce the pressure to below 80 PSI. The pressure reducing valve on the main service pipe is a common solution to this problem. It should be adjusted, repaired or replaced as necessary to maintain lower pressures. Note that having a pressure reducing valve creates a "closed system," which may require installing an expansion tank at the water heater where one is not already installed.

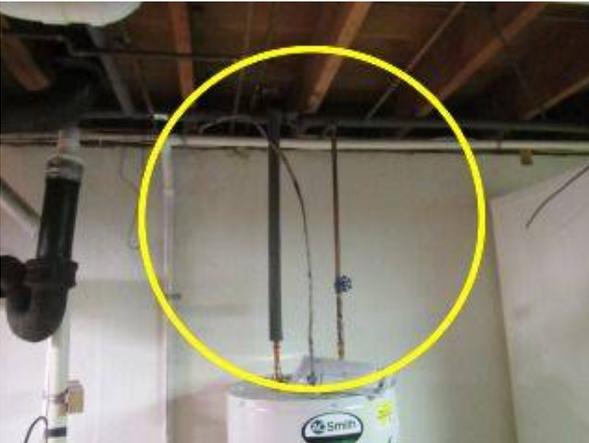
Photo 15-1

- No expansion tank was installed for the water supply system. Expansion tanks are recommended when a property is on a public water supply system and the property's water system is "closed" via a pressure reducing valve (PRV), check valve, or backflow preventer. No room for expansion of water exists in this type of system. Thermal expansion occurs when water is heated during non-use periods. In a closed system with no provision for expansion, its effects can include:

- Backflow into the water main
- Damage to water heater connections, gas water heater flue tubes and pumps serving washers and dishwashers
- Leaking faucets
- "Weeping" of water through the water heater temperature-pressure relief (TPR) valve
- Noisy water hammer in the pipes

Expansion tanks can eliminate these problems by giving water a place to go when thermal expansion occurs. When a water heating cycle ends, or when any fixture is opened within the system, the impact of thermal expansion is reduced, and water drains out of the expansion tank back into the system. Recommend that a qualified plumber install an expansion tank per standard building practices.

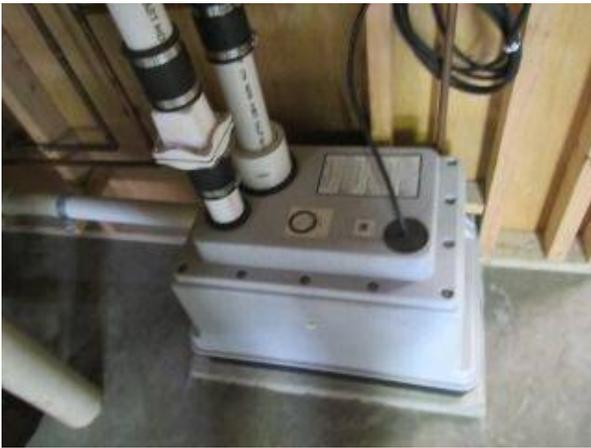
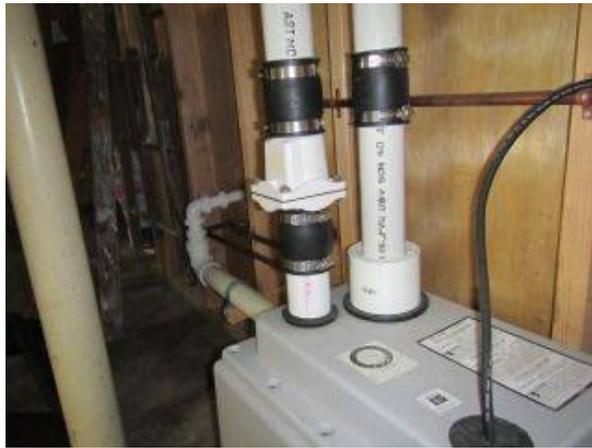
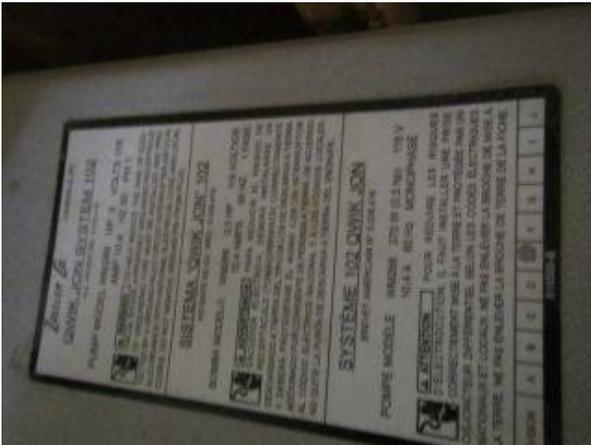
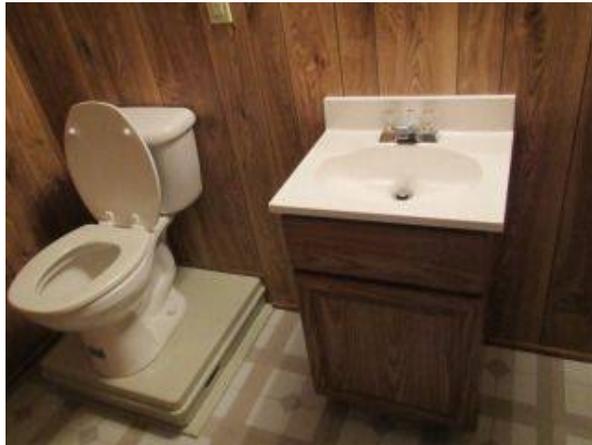
- A sewage ejector pump was installed on the premises. These are specialty systems and are excluded from this inspection. Comments in this report related to this system are made as a courtesy only and are not meant to be a substitute for a full evaluation by a qualified specialist. These systems are typically sealed and involve moving parts. They are subject to clogging and/or damage from disposal of items such as disposable diapers and sanitary napkins. Recommend that this pump and related equipment (piping, valves, etc.) be evaluated by a qualified plumber and repaired if necessary. This should be done per the manufacturer's recommendations in the future, or annually if unable to verify the manufacturer's recommendations. Typically, these pumps have a lifespan of 7-10 years. For more information, visit:

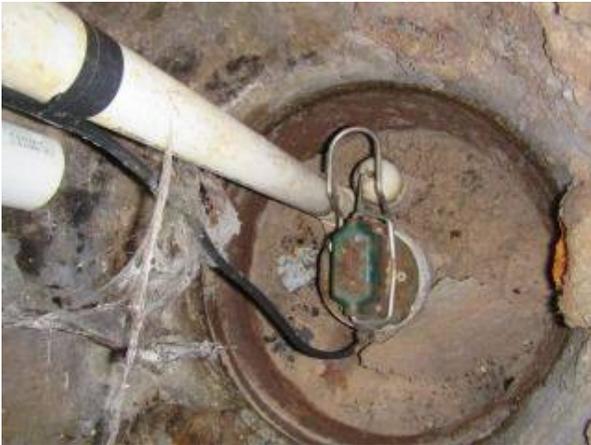
Photo 19-1

- No battery backup system was found for the sump pump. If the power goes out during heavy rains, the sump pump won't be able to eliminate accumulated water. Consider installing a battery backup system for the sump pump.

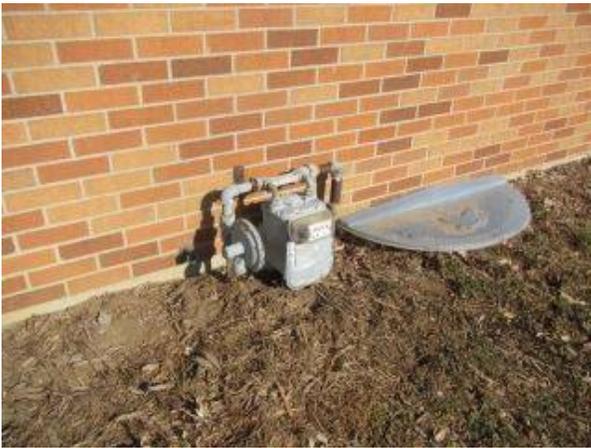
Photo 20-1

- The gas meter was in contact with or too close to the soil below and is likely to rust as a result. Gas meters should be located 10 inches or more above the soil below. Soil should be graded or removed as necessary.

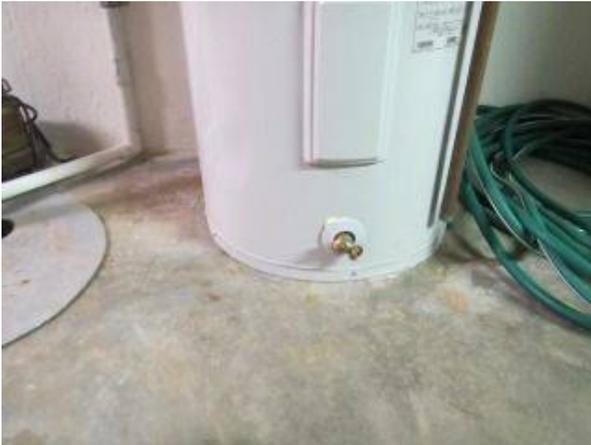
Photo 21-1

- The water heater was installed in an unheated space on a concrete floor and was not resting on an insulated pad. The bottom of the casing is likely to rust, and energy efficiency may be reduced. Recommend installing an insulated pad under the water heater.

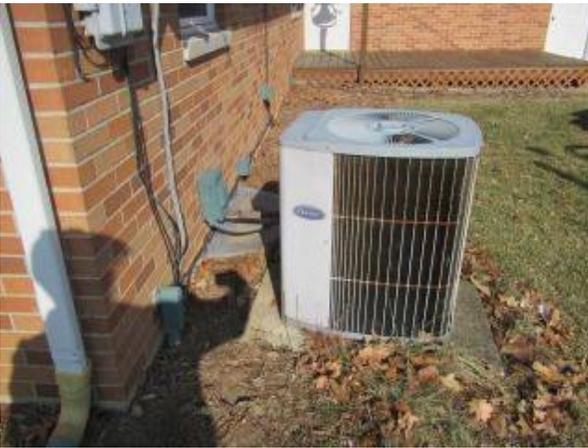
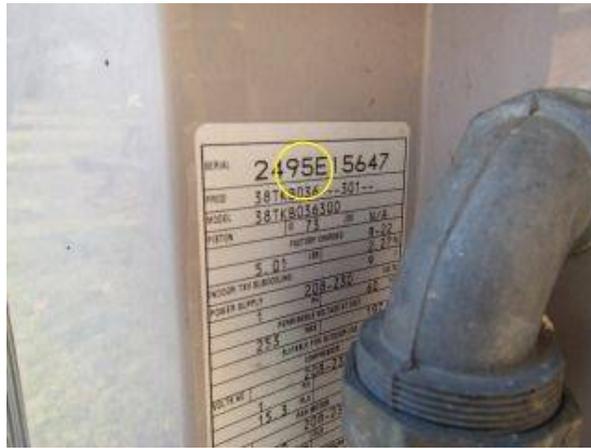
- The estimated useful life for most conditioning condensing units is 10-15 years. This unit appeared to be near, at and/or beyond this age and/or its useful lifespan and may need replacing or significant repairs at any time. Recommend budgeting for a replacement in the near future.

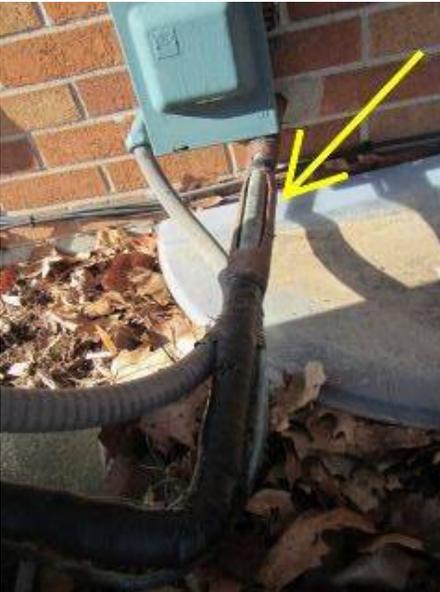
Photo 24-1

**24** 🔧 - Insulation on the air conditioning condensing unit's refrigerant lines was deteriorated or missing in some areas. This may result in reduced efficiency and increased energy costs. Recommend that a qualified person replace or install insulation as necessary.

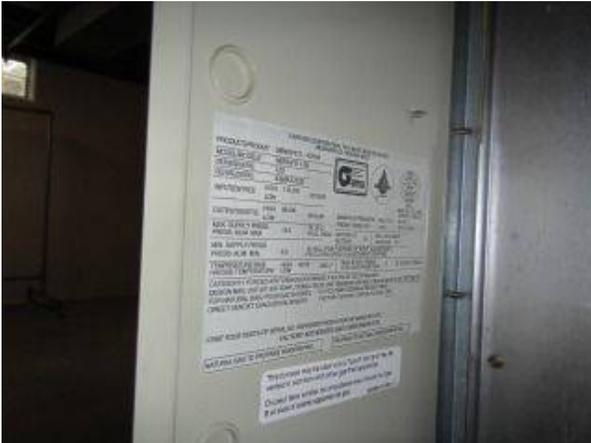
Photo 26-1

- The estimated useful life for most forced air furnaces is 15-20 years. This furnace was manufactured in 1994 and appeared to be near its useful lifespan and may need replacing or significant repairs at any time. Recommend budgeting for a replacement in the near future.

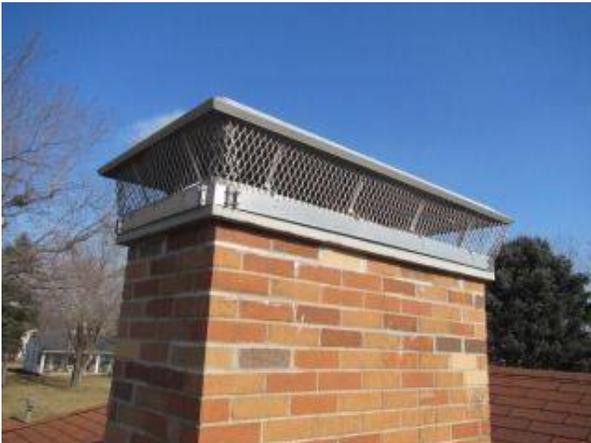
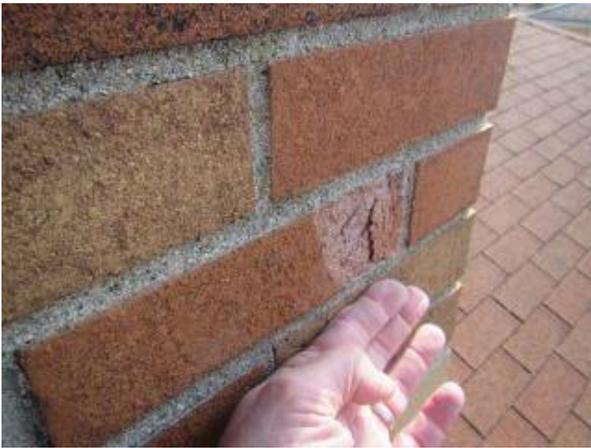
- Spalled brick was found on the brick chimney in two places near the cap. Deteriorated brick or masonry can allow water to infiltrate the chimney structure and cause further damage. Recommend that a qualified contractor repair as necessary.

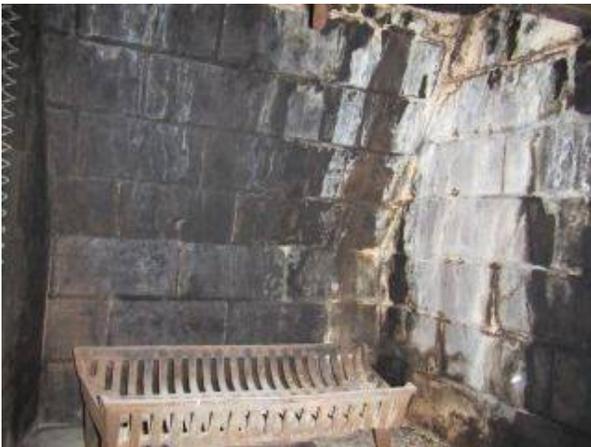
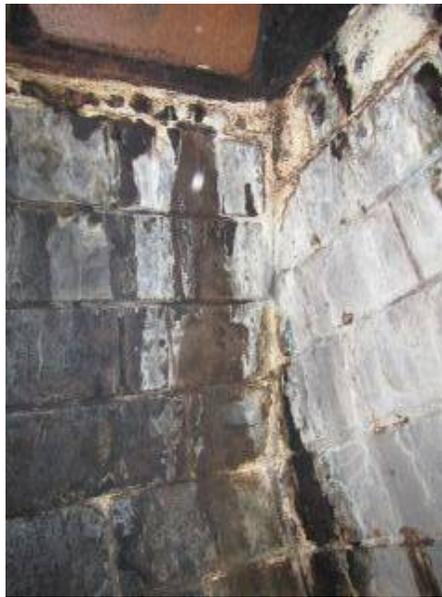
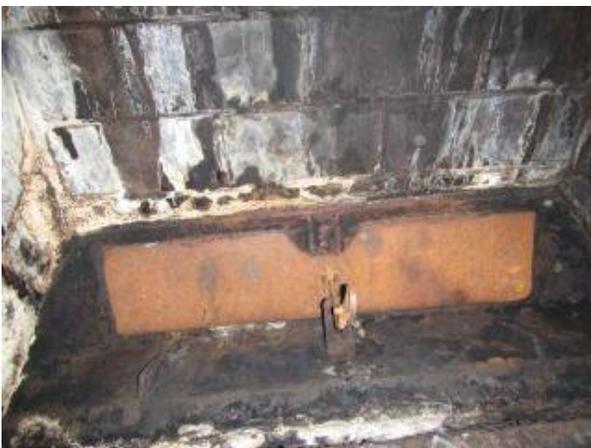
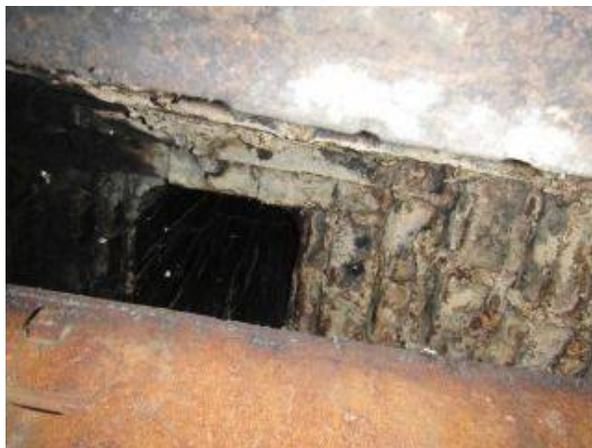
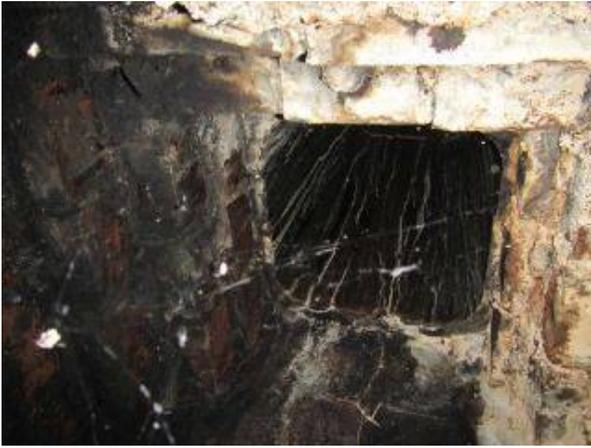
- Signs of past water infiltration, drip marks in the flue, were seen. The chimney has a newer cap to keep out water and animals so I believe this old damage and not a point of concern. I would monitor this carefully.

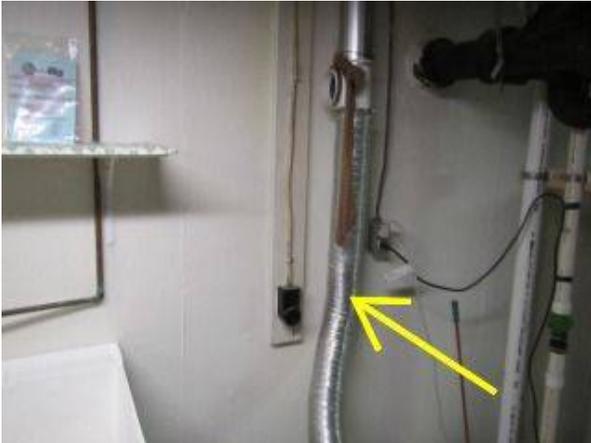
Photo 29-1

- The clothes dryer vent in basement was equipped with a vinyl or mylar, accordion-type, flexible exhaust duct. The U.S. Consumer Product Safety Commission considers these types of ducts to be unsafe, and a fire hazard. They can trap lint and are susceptible to kinks or crushing, which can greatly reduce the air flow and cause overheating. Recommend that such ducts be replaced with a rigid or corrugated semi-rigid metal duct, and by a qualified contractor if necessary. For more information, visit: <http://www.reporthost.com/?DRYER>

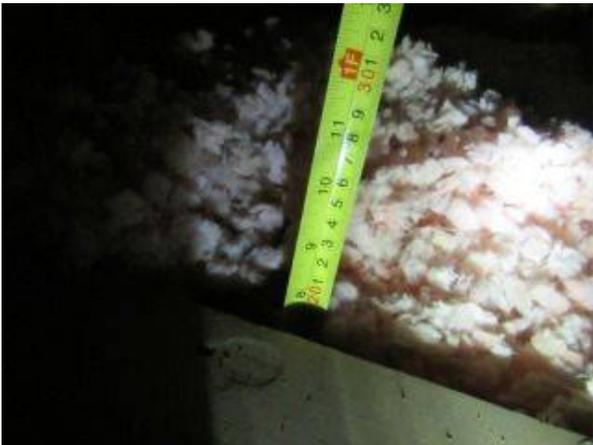
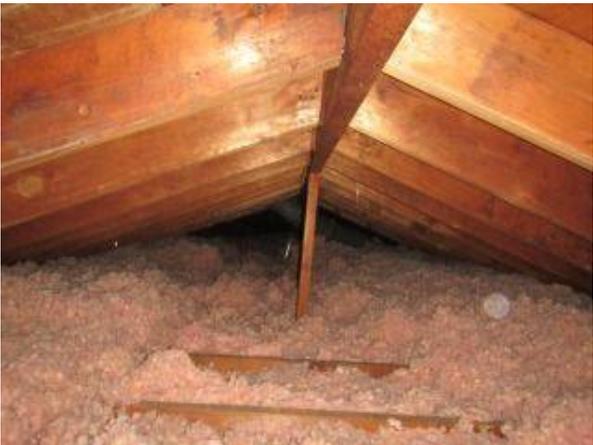
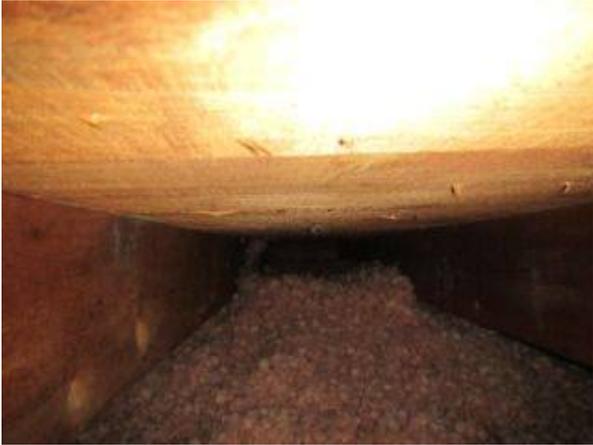
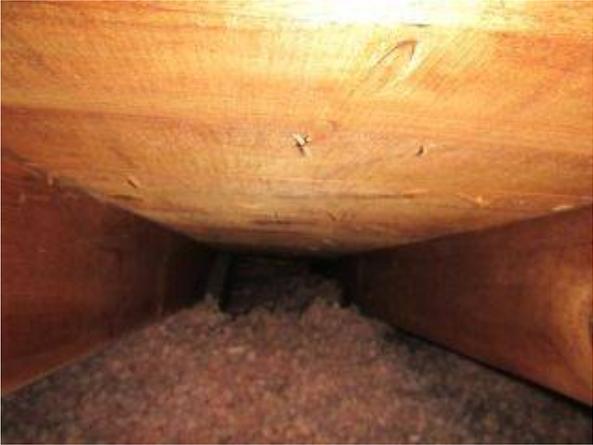
- The ceiling insulation in one or more areas of the attic was substandard. Heating and cooling costs may be higher due to reduced energy efficiency. Recommend that a qualified person repair, replace or install insulation as necessary and per standard building practices (typically R-38).

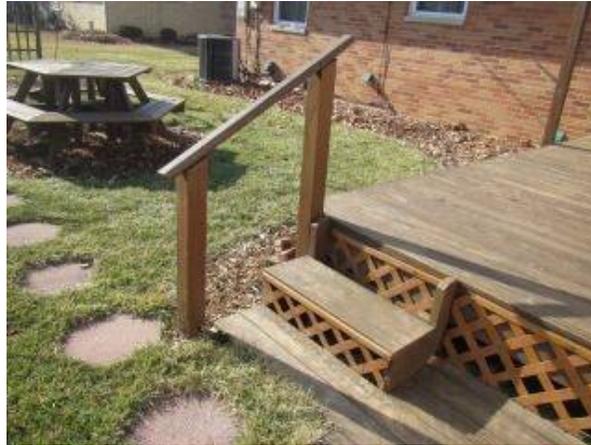
Photo 2-2

Wooden deck or porch surfaces were overdue for normal maintenance. Recommend that a qualified person clean and preserve as necessary. Where decks have been coated with a finish such as opaque stains or paint, it may be too difficult to strip the finish and apply anything but paint or opaque stain. Where transparent stain or penetrating oil has been applied in the past, recommend that a penetrating oil be used. For more information, visit:

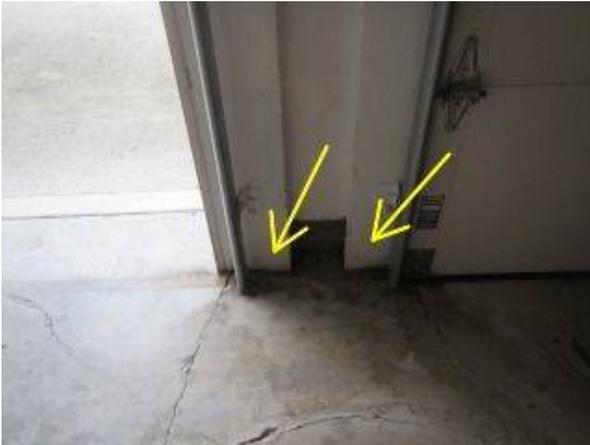
Photo 4-1

No photoelectric sensors were installed for one or more garage vehicle doors' automatic opener. These have been required on all automatic door openers since 1993 and improve safety by triggering the door's auto-reverse feature without need for the door to come in contact with the object, person or animal that is preventing the door from closing. Recommend that a qualified contractor install photoelectric sensors where missing for improved safety. For more information on garage door safety issues, visit:

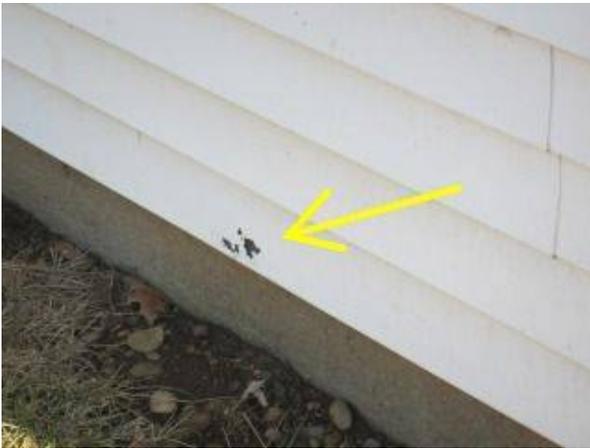
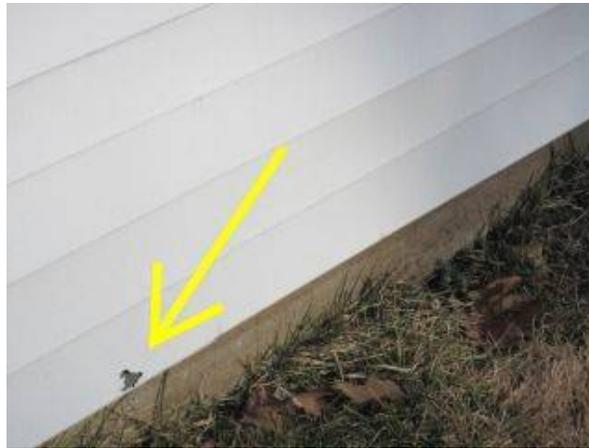
Minor chipping of vinyl siding at ground level probably caused by a weed wacker. Recommend monitoring. Potential for moisture intrusion and wood destroying organisms.

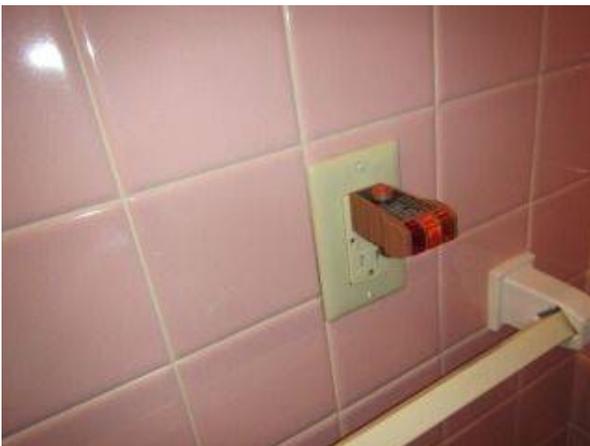
Photo 7-1

One ground fault circuit interrupter (GFCI) receptacles (outlets) wouldn't trip with a test instrument at the bathroom off the 1st floor hall. This is a potential shock hazard. Recommend that a qualified electrician evaluate and repair as necessary.

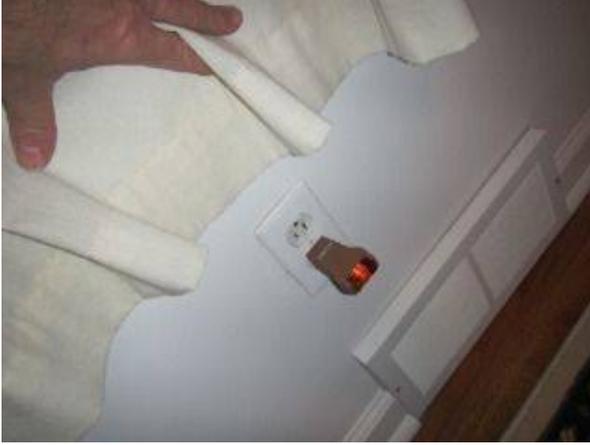
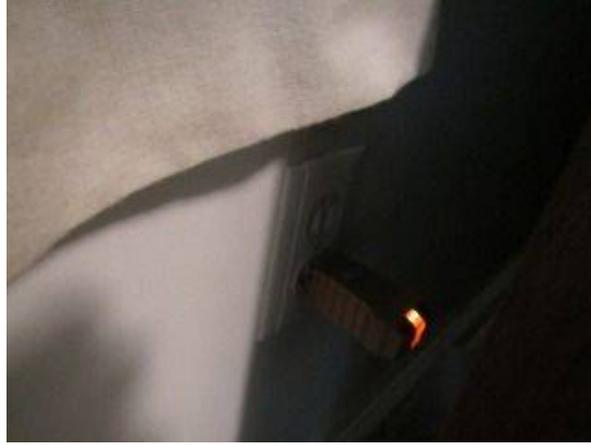
One or more modern, 3-slot electric receptacles (outlets) were found with an open ground. Three-slot receptacles should have a hot, a neutral and a ground wire connected. Homeowners often install new 3-slot receptacles on older, 2-wire circuits that only have

hot and neutral wires. This is a shock hazard when appliances that require a ground are used with these receptacles. Examples of such appliances include computers and related hardware, refrigerators, freezers, portable air conditioners, clothes washers, aquarium pumps, and electrically operated gardening tools. Where the electric system was installed prior to when grounded circuits were required (1960s), it is permissible to replace 3-slot receptacles with 2-slot receptacles to prevent appliances that require a ground from being plugged in to an ungrounded circuit. However, the client should be aware of this limitation when planning use for various rooms, such as an office. For newer electric systems, circuits should be repaired so grounded, 3-wire cables provide power to 3-slot receptacles. Recommend that a qualified electrician repair per standard building practices.

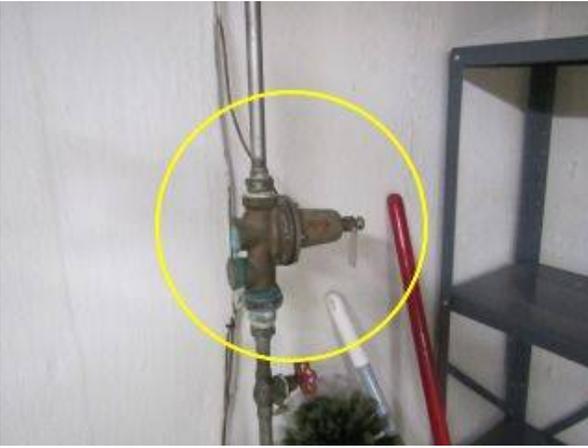
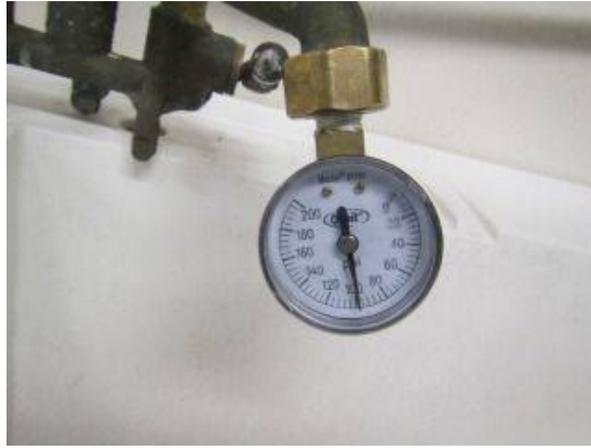
** The water supply pressure from the public supply was greater than 80 pounds per square inch (PSI). Pressures above 80 PSI may void warranties for some appliances such as water heaters or washing machines. Flexible supply lines to washing machines are likely to burst with higher pressures. 40-80 PSI is considered the normal range for water pressure in a home, and most plumbers recommend 50-60 PSI. Typically, the pressure cannot be regulated at the water meter. Recommend that a qualified plumber evaluate and make modifications to reduce the pressure to below 80 PSI. The pressure reducing valve on the main service pipe is a common solution to this problem. It should be adjusted, repaired or replaced as necessary to maintain lower pressures. Note that having a pressure reducing valve creates a "closed system," which may require installing an expansion tank at the water heater where one is not already installed.

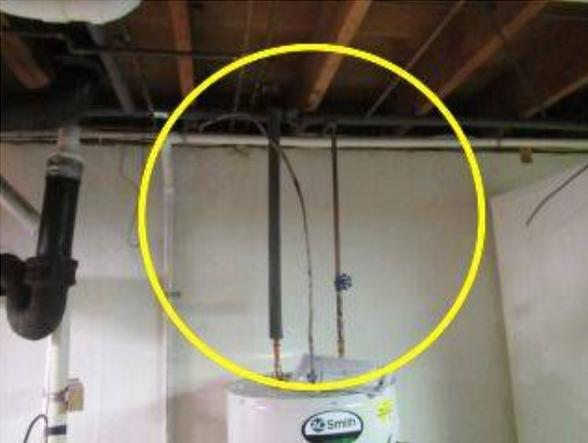
Photo 15-1

- Backflow into the water main
- Damage to water heater connections, gas water heater flue tubes and pumps serving washers and dishwashers
- Leaking faucets
- "Weeping" of water through the water heater temperature-pressure relief (TPR) valve
- Noisy water hammer in the pipes

Expansion tanks can eliminate these problems by giving water a place to go when thermal expansion occurs. When a water heating cycle ends, or when any fixture is opened within the system, the impact of thermal expansion is reduced, and water drains out of the expansion tank back into the system. Recommend that a qualified plumber install an expansion tank per standard building practices.

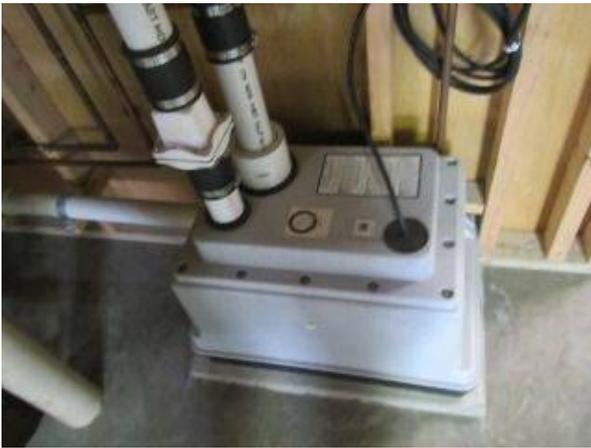
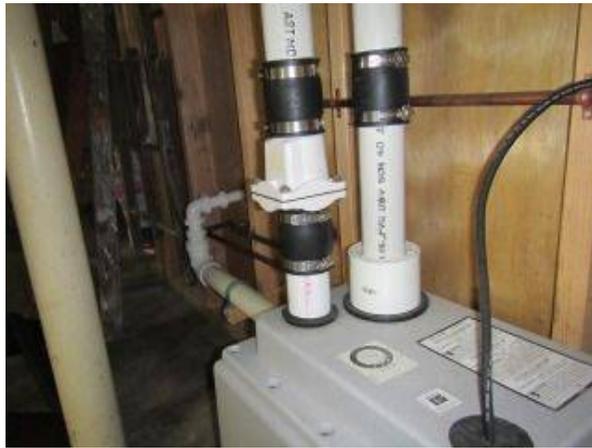
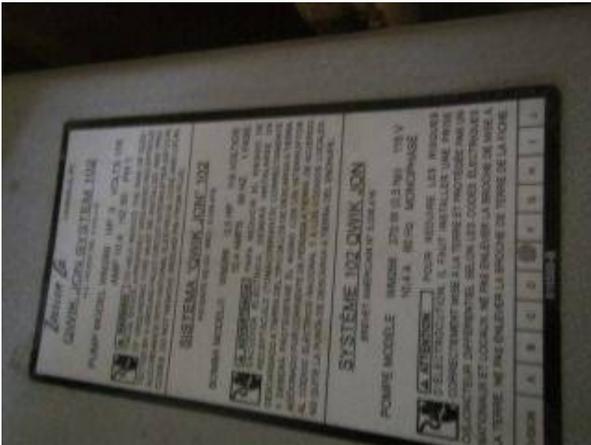
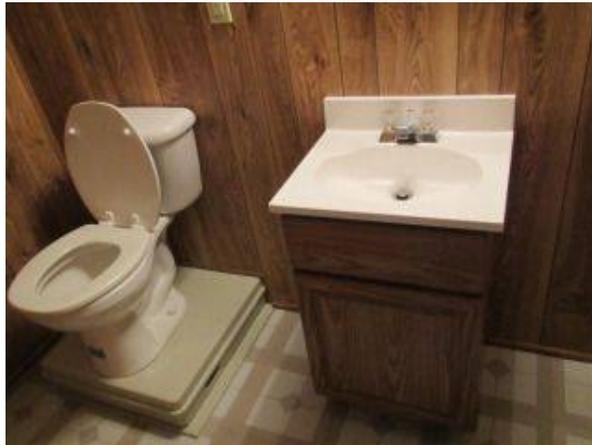
A sewage ejector pump was installed on the premises. These are specialty systems and are excluded from this inspection. Comments in this report related to this system are made as a courtesy only and are not meant to be a substitute for a full evaluation by a qualified specialist. These systems are typically sealed and involve moving parts. They are subject to clogging and/or damage from disposal of items such as disposable diapers and sanitary napkins. Recommend that this pump and related equipment (piping, valves, etc.) be evaluated by a qualified plumber and repaired if necessary. This should be done per the manufacturer's recommendations in the future, or annually if unable to verify the manufacturer's recommendations. Typically, these pumps have a lifespan of 7-10 years. For more information, visit:

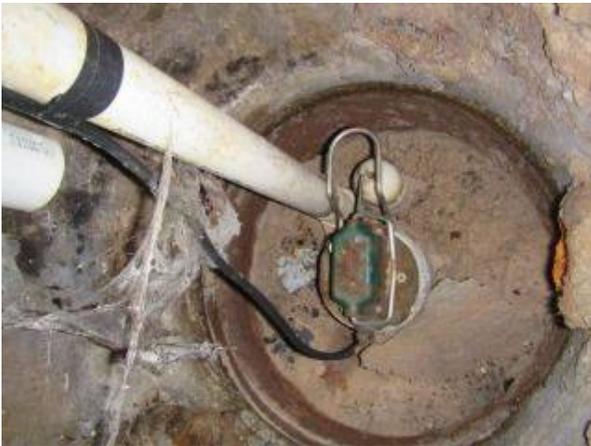
Photo 19-1

No battery backup system was found for the sump pump. If the power goes out during heavy rains, the sump pump won't be able to eliminate accumulated water. Consider installing a battery backup system for the sump pump.

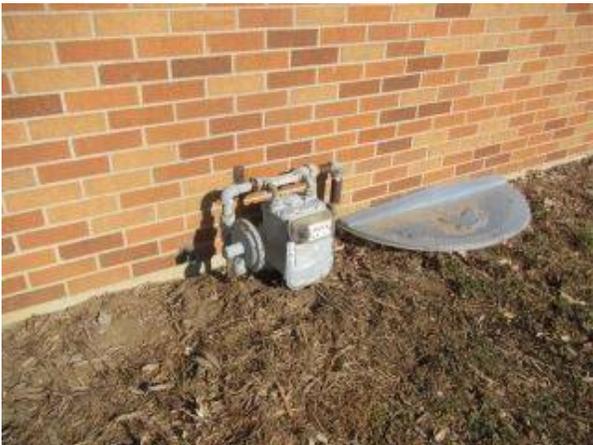
Photo 20-1

The gas meter was in contact with or too close to the soil below and is likely to rust as a result. Gas meters should be located 10 inches or more above the soil below. Soil should be graded or removed as necessary.

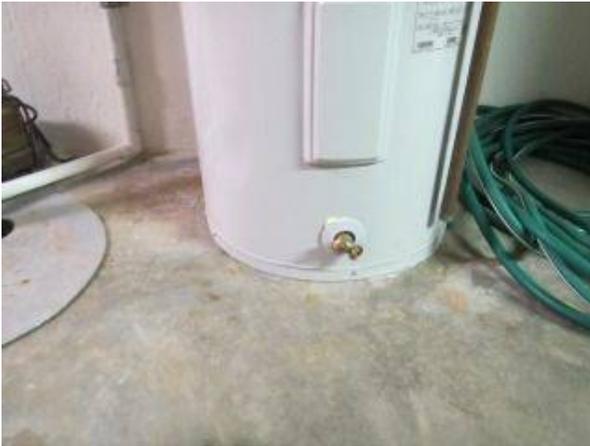
**Photo 21-1**

The water heater was installed in an unheated space on a concrete floor and was not resting on an insulated pad. The bottom of the casing is likely to rust, and energy efficiency may be reduced. Recommend installing an insulated pad under the water heater.

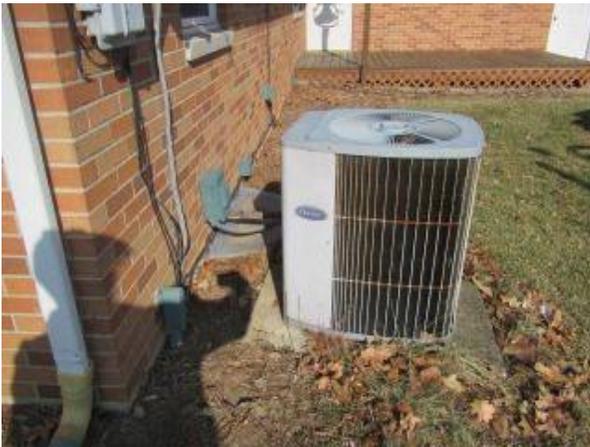
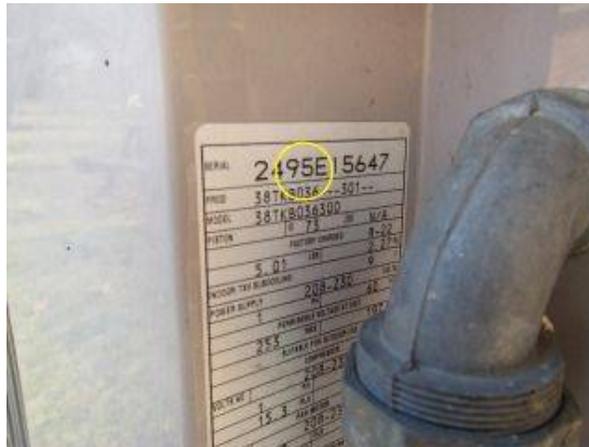
The estimated useful life for most conditioning condensing units is 10-15 years. This unit appeared to be near, at and/or beyond this age and/or its useful lifespan and may need replacing or significant repairs at any time. Recommend budgeting for a replacement in the near future.

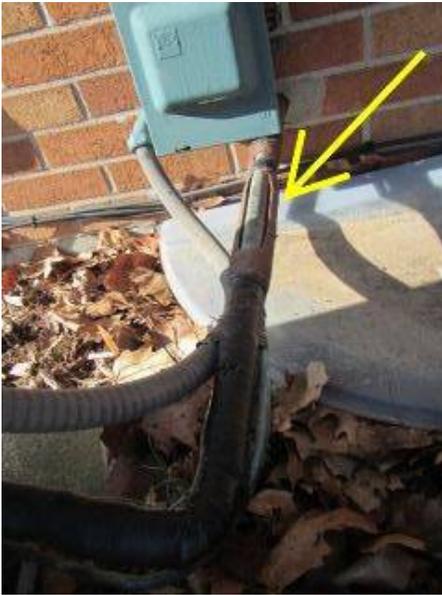
Photo 24-1

Insulation on the air conditioning condensing unit's refrigerant lines was deteriorated or missing in some areas. This may result in reduced efficiency and increased energy costs. Recommend that a qualified person replace or install insulation as necessary.

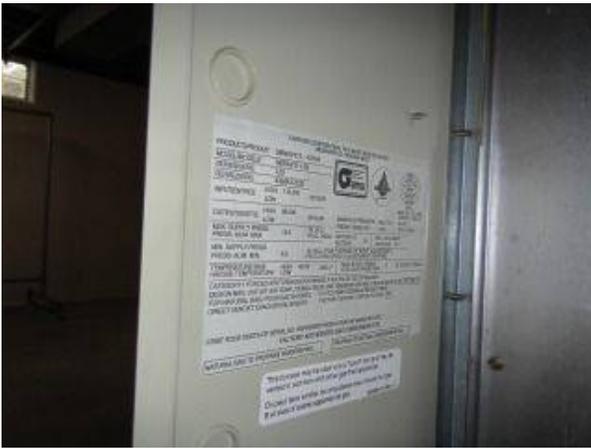
Photo 26-1

The estimated useful life for most forced air furnaces is 15-20 years. This furnace was manufactured in 1994 and appeared to be near its useful lifespan and may need replacing or significant repairs at any time. Recommend budgeting for a replacement in the near future.

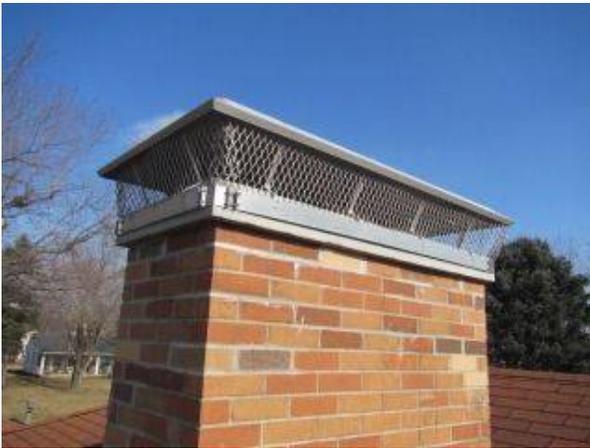
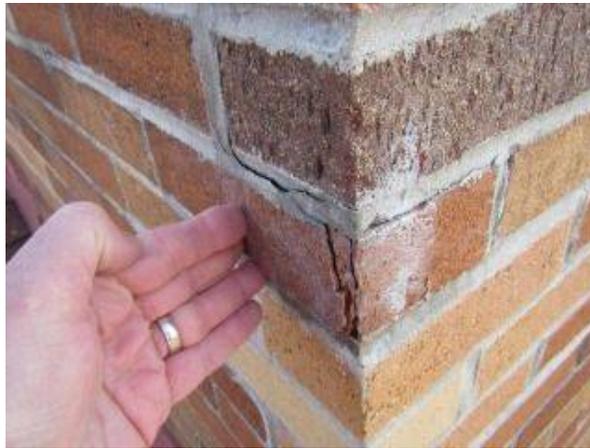
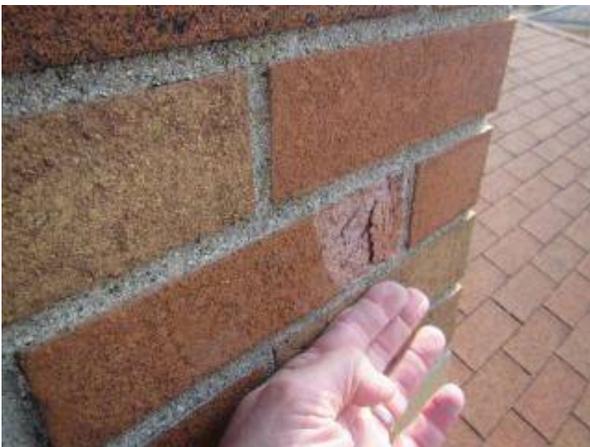
27) 🛠️🔧 Spalled brick was found on the brick chimney in two places near the cap. Deteriorated brick or masonry can allow water to infiltrate the chimney structure and cause further damage. Recommend that a qualified contractor repair as necessary.

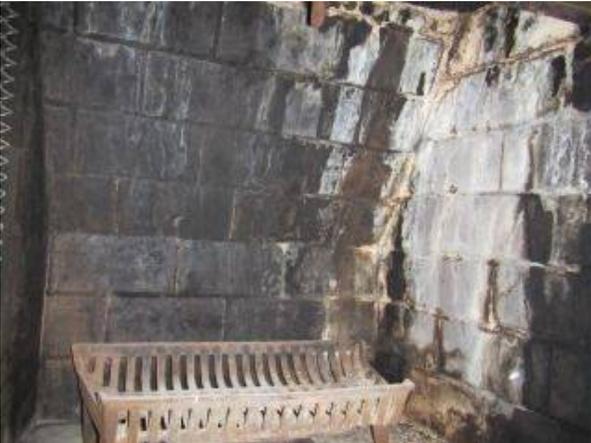
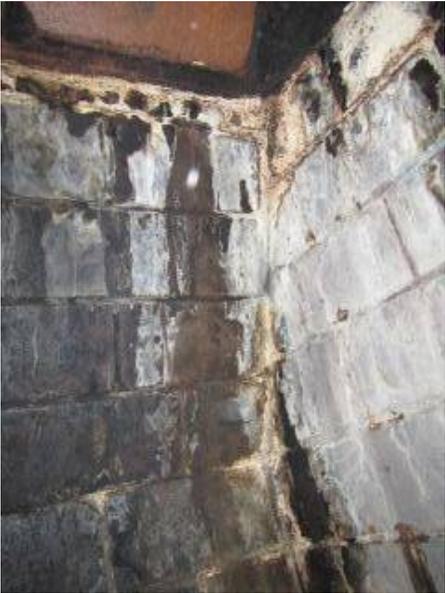
28) 🏠📍 Signs of past water infiltration, drip marks in the flue, were seen. The chimney has a newer cap to keep out water and animals so I believe this old damage and not a point of concern. I would monitor this carefully.

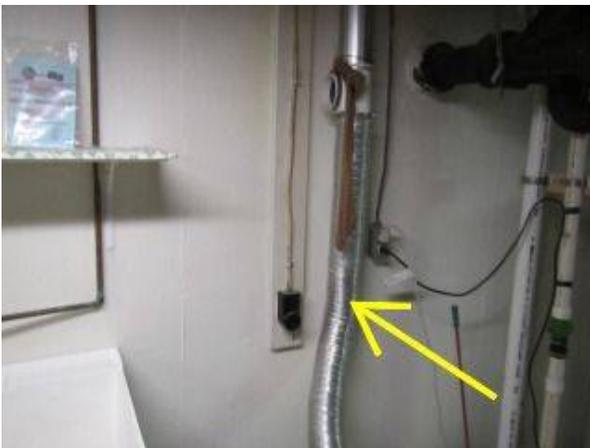
Photo 29-1

The clothes dryer vent in basement was equipped with a vinyl or mylar, accordion-type, flexible exhaust duct. The U.S. Consumer Product Safety Commission considers these types of ducts to be unsafe, and a fire hazard. They can trap lint and are susceptible to kinks or crushing, which can greatly reduce the air flow and cause overheating. Recommend that such ducts be replaced with a rigid or corrugated semi-rigid metal duct, and by a qualified contractor if necessary. For more information, visit:

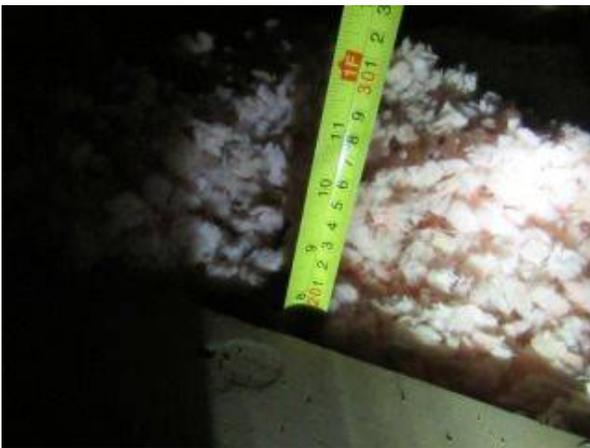
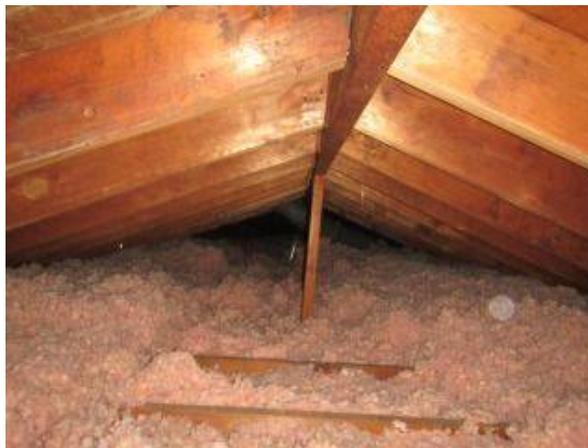
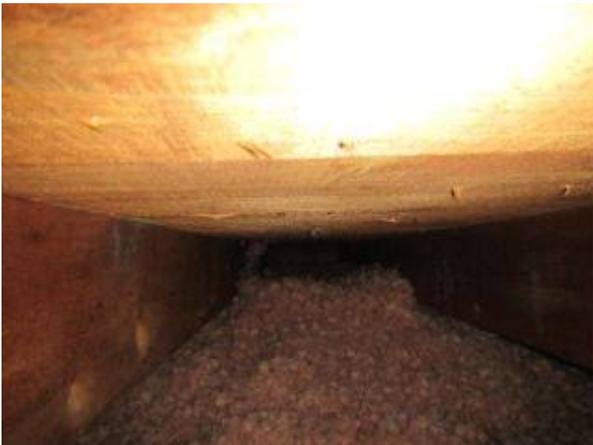
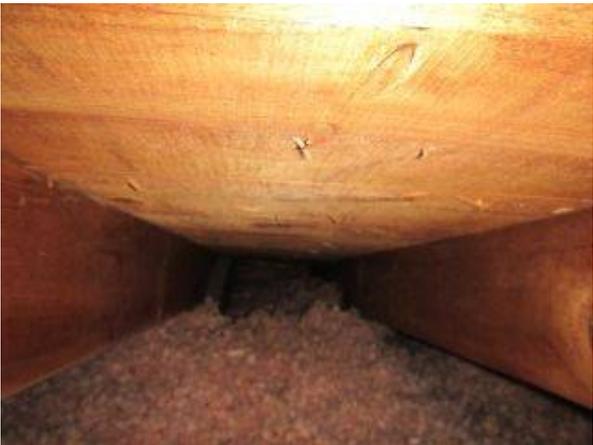
The ceiling insulation in one or more areas of the attic was substandard. Heating and cooling costs may be higher due to reduced energy efficiency. Recommend that a qualified person repair, replace or install insulation as necessary and per standard building practices (typically R-38).
