## Summary

Property address: **Fairfield OH 45014**

Inspection date: **Wednesday, January 21, 2015**

## Residential Property Inspection Report

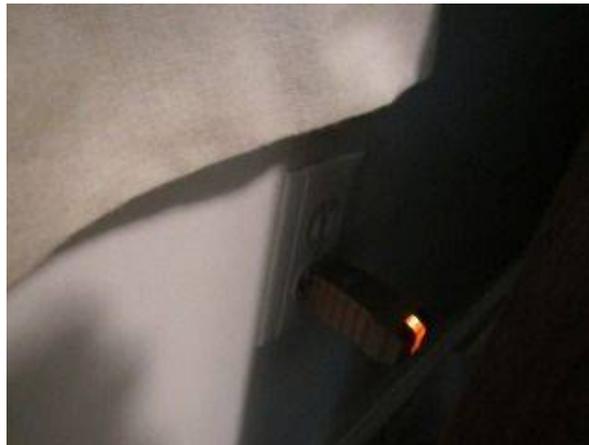
Photo 8-2

- One or more modern, 3-slot electric receptacles (outlets) were found with an open ground. Three-slot receptacles should have a hot, a neutral and a ground wire connected. Homeowners often install new 3-slot receptacles on older, 2-wire circuits that only have hot and neutral wires. This is a shock hazard when appliances that require a ground are used with these receptacles. Examples of such appliances include computers and related hardware, refrigerators, freezers, portable air conditioners, clothes washers, aquarium pumps, and electrically operated gardening tools. Where the electric system was installed prior to when grounded circuits were required (1960s), it is permissible to replace 3-slot receptacles with 2-slot receptacles to prevent appliances that require a ground from being plugged in to an ungrounded circuit. However, the client should be aware of this limitation when planning use for various rooms, such as an office. For newer electric systems, circuits should be repaired so grounded, 3-wire cables provide power to 3-slot receptacles. Recommend that a qualified electrician repair per standard building practices.

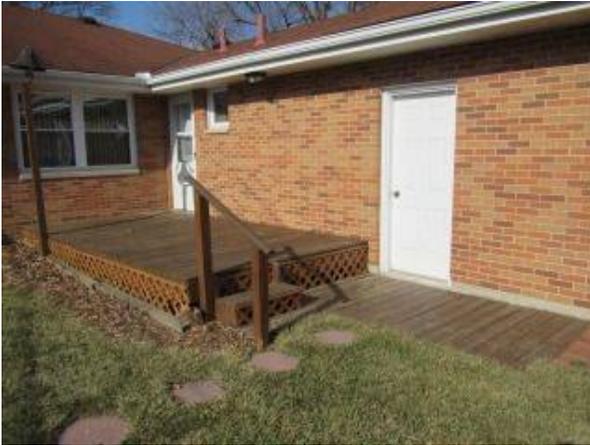
Photo 2-1

- Wooden deck or porch surfaces were overdue for normal maintenance. Recommend that a qualified person clean and preserve as necessary. Where decks have been coated with a finish such as opaque stains or paint, it may be too difficult to strip the finish and apply anything but paint or opaque stain. Where transparent stain or penetrating oil has been applied in the past, recommend that a penetrating oil be used. For more information, visit:
